ULTRASONIC KIT DEFECT LOCATION DETAILS

Certificate of Conformance

ULTRASONIC INSPECTION NDE Specimens

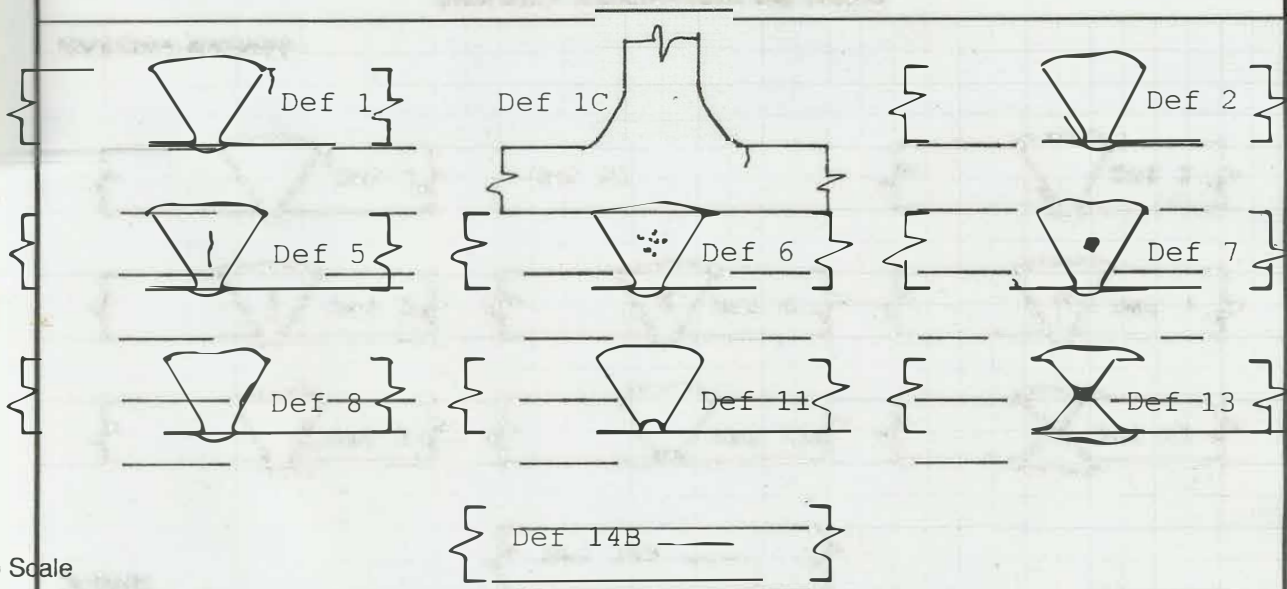
Weld Cross Section(s):-

DEFECT NO.	DEFECT TYPE	DEFECT * LENGTH (mm/in)	DEFECT LOCATION (PLAN)	NDE DISCIPLINE	
				UT	RT+
1	Toe Crack	25/1.00	Central	✓	✓
1C	Toe Crack	25/1.00	Central	✓	
2	Root Crack	25/1.00	Central	✓	✓
5	Centre Line Crack	25/1.00	Central	✓	✓
6	Porosity	25/1.00	Central	✓	✓
7	Slag Inclusion	25/1.00	Central	✓	✓
8	L.O.S.W. Fusion	25/1.00	Central	✓	✓
11	Incomplete Root Pen. SV	25/1.00	Central	✓	✓
13	Incomplete Root Pen. DV	25/1.00	Central	✓	✓
14B	Lamination	25/1.00	Central	✓

The above drawings are representative of defect through wall location and through wall dimensions, not actual.
