**Morphological and tribological evaluation of the use of Ti_2AlC
and Ti_3AlC_2 MAX Phases as a surgical AISI 304 stainless steel
coating for a future hip replacement femoral head coating**

Tesis para obtener el título profesional de Ingeniera Biomédica

Gianella Alexandra Ccama Castro

Lima, Diciembre, 2023

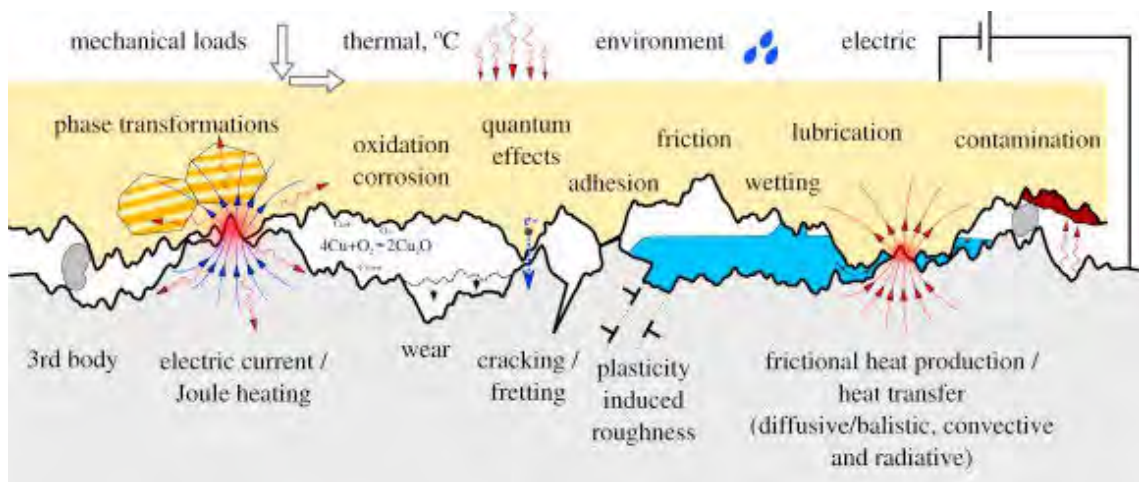
Figure 1.1: Graphical representation of the tribological interactions between two surfaces in contact with each other (Vakis et al. 2018)

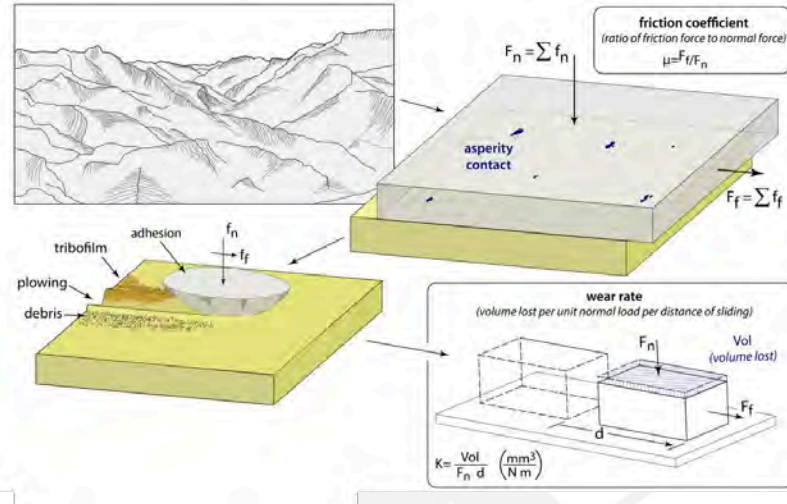
Figure 1.2: Graphical representation of parameters coefficient of friction and Wear Rate (*Tri-bology Laboratory at Lehigh University: 2012*)

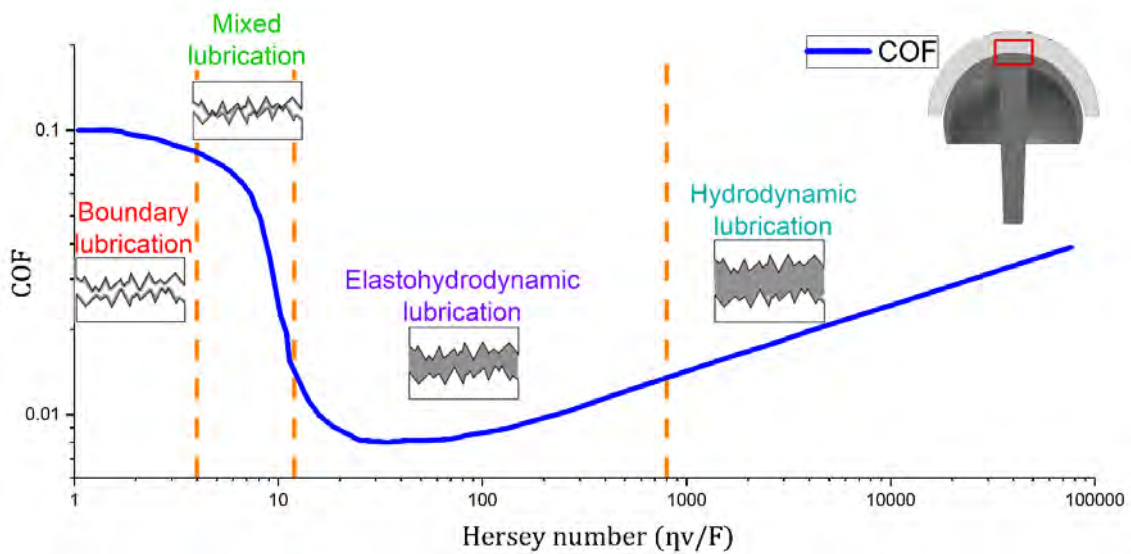
Figure 1.3: Representation of the Stribeck curve and its regimes developed in Origin. Adapted from (Kretzer 2013)

Lubricants comply with four lubrication regimes (hydrodynamic, elastohydrodynamic, mixed and boundary) Figure 1.3, where behavior of the coefficient of friction depending on the lubricant thickness (according to the Hersey number) is plotted on the Stribeck curve. The friction coefficient depends on the Hersey number such that it is equal to the product of the dynamic viscosity times the rotational speed (v) divided by the average load (F) (Y. Wang and Q. J. Wang 2013). In the regime for boundary lubrication, the surfaces are covered with a thin film of lubricant where friction and wear are determined primarily by the properties of the contact surfaces and secondarily by the properties of the lubricant. In the case of mixed film lubrication there is a space partially covered by a lubricant film where the load is supported by both the lubricant film and the spray forces, a decrease in coefficient of friction can be observed. The elastohydrodynamic lubrication regime is often confused as part of the mixed film regime, but this is characterized by having a continuous and uninterrupted lubricant film between the contact surface and the dynamic viscosity of the lubricant alone controls the friction properties, since the surfaces do not show wear. Finally, there is hydrodynamic lubrication which is characterized by a relatively thick lubricant film where surfaces do not wear and rigid body geometries are assumed, as well as the constant viscosity of the lubricants (Dowson 2012; Scharf and Prasad 2013; Y. Wang and Q. J. Wang 2013; Wäsche and Woydt 2014; Z. Xu et al. 2015).

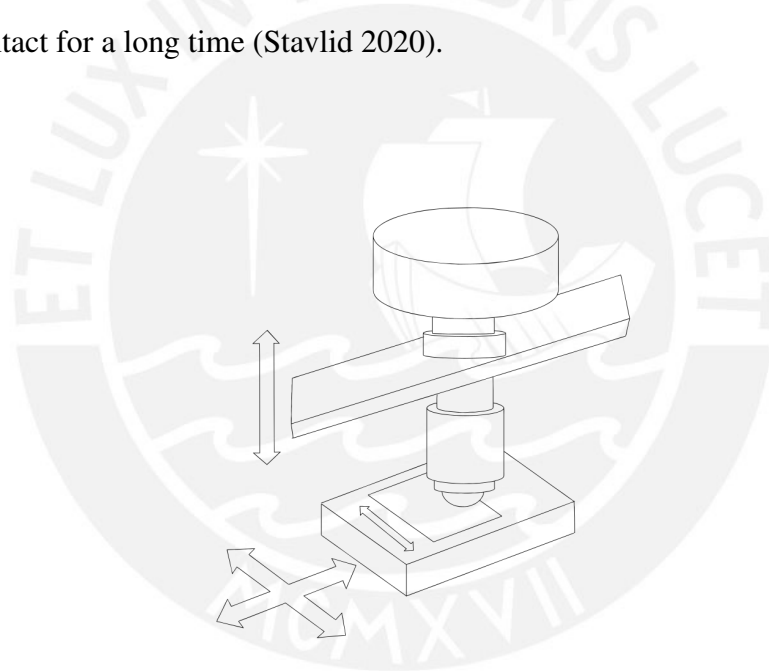
Figure 1.5: Schematic of a ball on flat tribometer.

Therefore, this configuration can be used as a model test for mechanical component surfaces that are subjected to high loads. Its wear debris can be pushed in front of the top sample and remain in contact for a long time (Stavlid 2020).

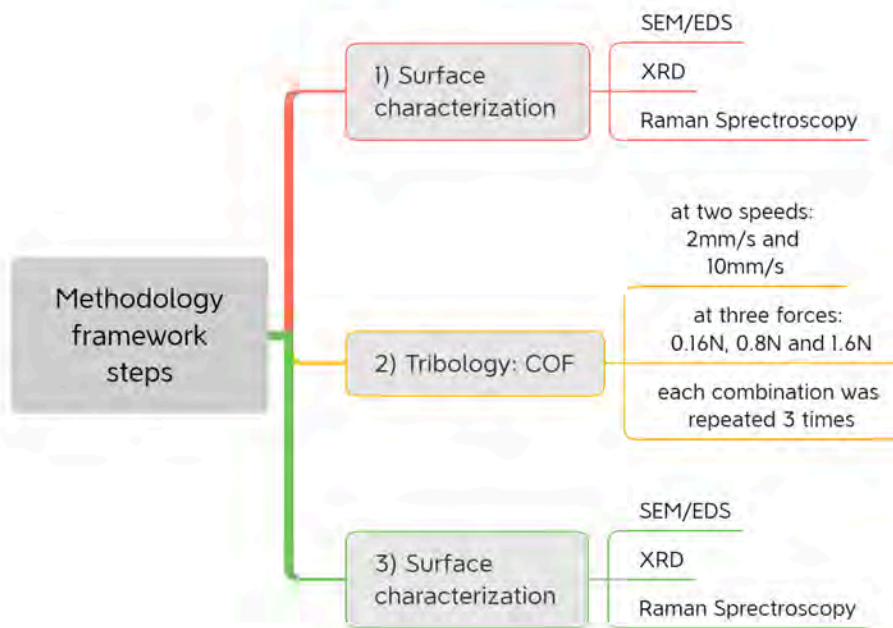
Figure 2.1: Workflow synthesis of the project: 1) To determine if the coatings were produced, the surface must first be characterized. 2) The tribological test simulate joint movement and its wear. 3) An evaluation of the final surface characterisation enables a comparison to determine if the coatings were damaged and how the byproducts are distributed.

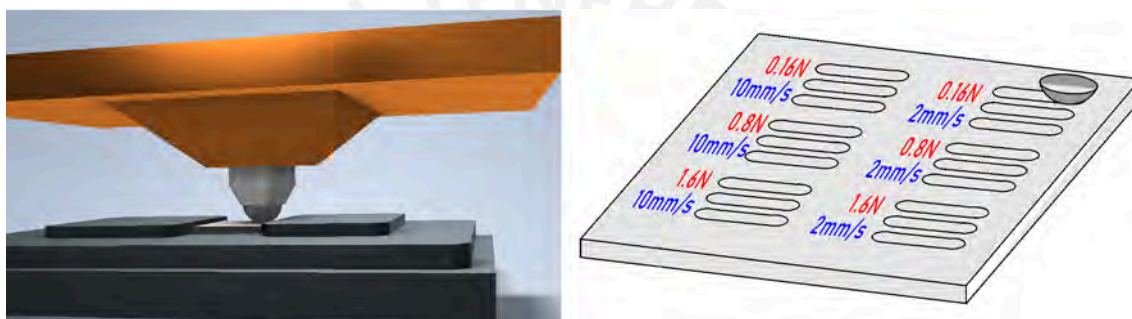
Figure 2.2: Ball-on-flat tribometer schematic and distribution of tracks in each sample.

Each test lasted 15 minutes, had a 2.5 mm stroke length, and was conducted with two sliding velocities in the hip joint's typical range (2 mm s^{-1} and 10 mm s^{-1}) while varying the normal loads (0.16, 0.8, and 1.6 N). A AISI 52100 steel ball (radius of 4 mm) served as the counterpart in all experiments, and it was changed for each sample. Each velocity and normal force were mixed in 6 different combinations (Figure 2.1), then repeated three times in a row. Each sample included 18 tracks. (Figure 2.2).

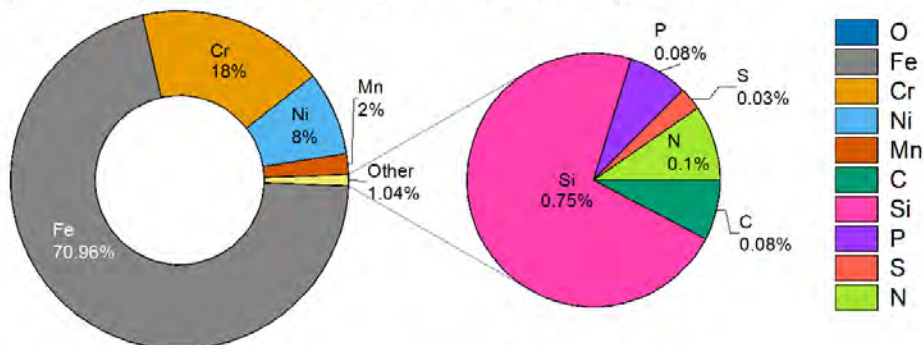
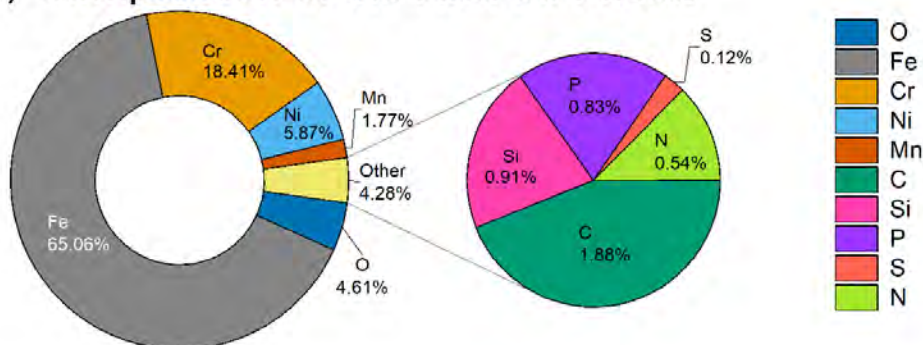
Figure 3.1: Atomic Concentration comparison of standard AISI 304 and the steel substrate used for coated samples. Based on (AlHaza and Haneklaus 2020; Borba et al. 2020)

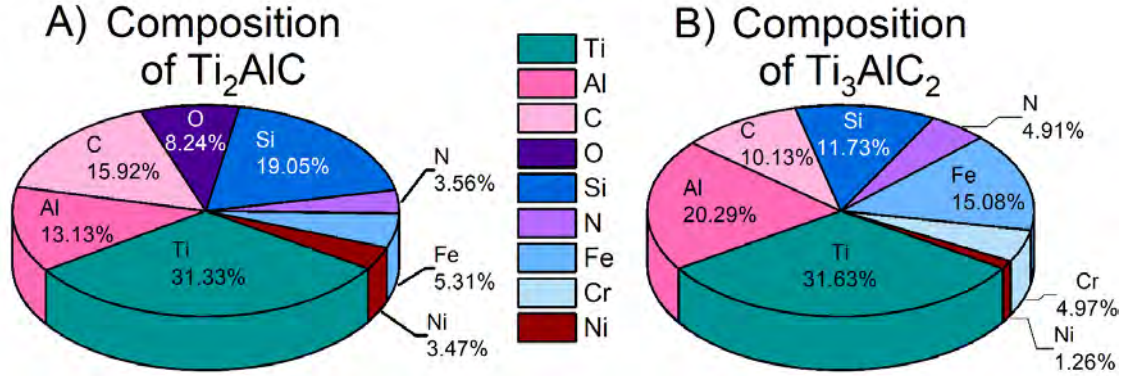
Figure 3.2: Atomic Concentration of selected elements found in the MAX phase coated samples.

concentration supports the creation of the diffusion barrier Si_xN_y . (15 KV).

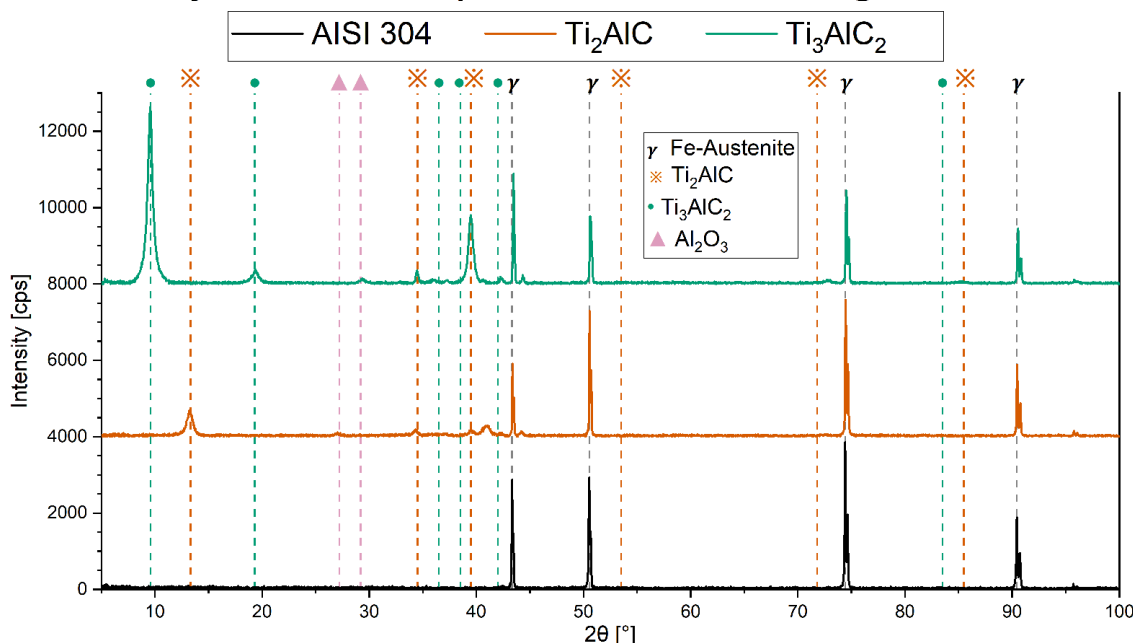
Figure 3.3: Bragg Brentano configuration-X-Ray diffraction patterns of AISI 304 stainless steel, MAX Ti_2AlC at 700°C MAX and Ti_3AlC_2 at 950°C

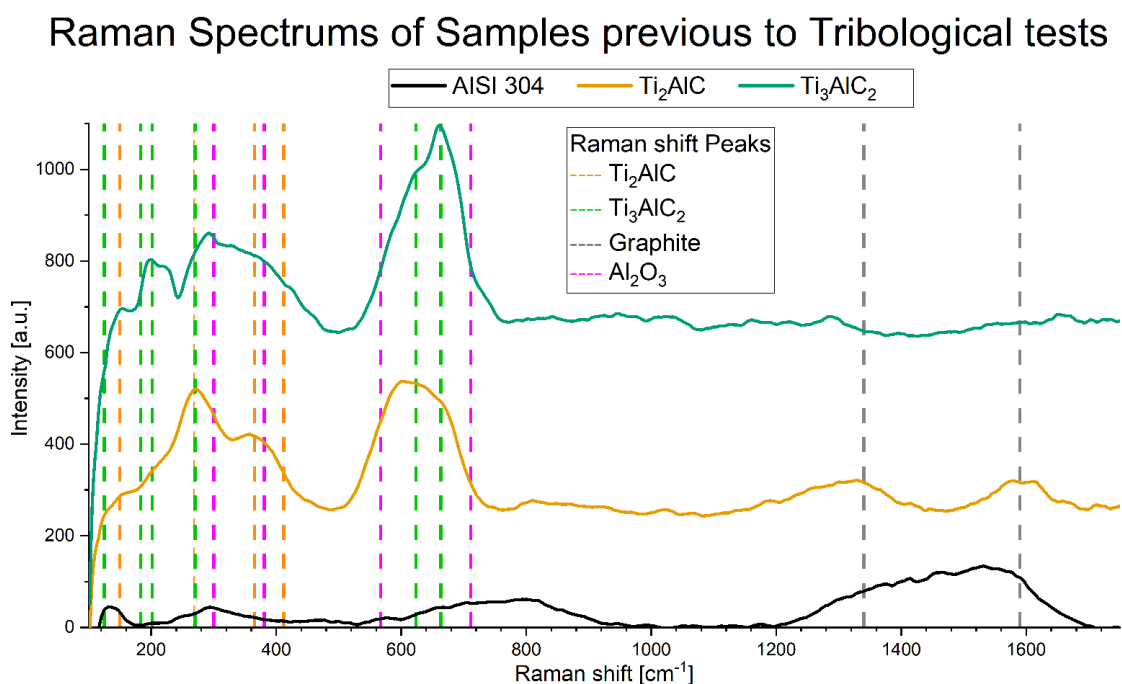
Figure 3.4: Raman spectrums of AISI 304 stainless steel, MAX Ti_2AlC at 700°C MAX and Ti_3AlC_2 at 950°C

According to the results, the coatings composition is predicted to conform to the composition of Ti_2AlC or Ti_3AlC_2 MAX phases.

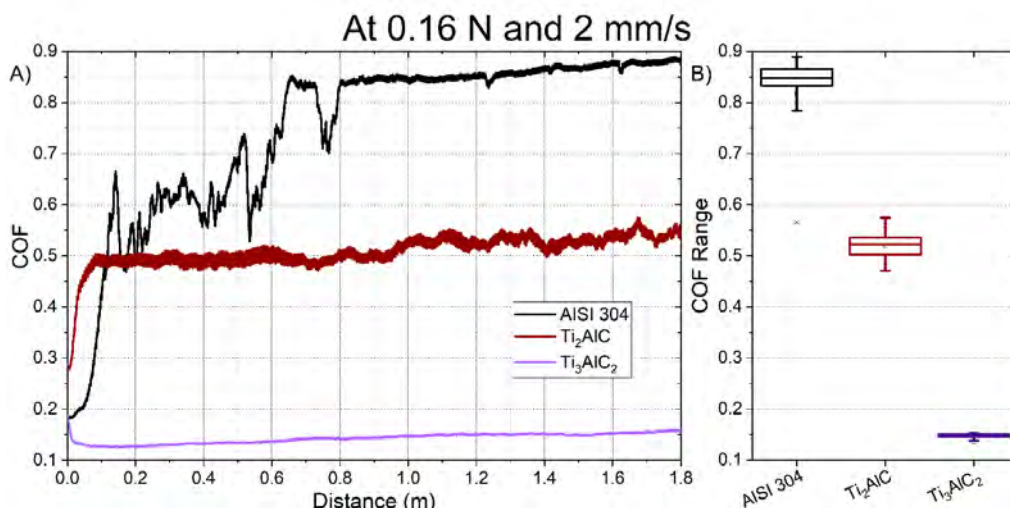
Figure 3.5: COF analysis for Steel, Ti_2AlC and Ti_3AlC_2 at 2 mm s^{-1} and 0.16 N .

stabilizes around 0.85 (upper 75% quantile), which is the average for this steel. This running-in affects the COF of all AISI 304 tested, but it was previously reported that this AISI 304 have this behavior (Dib et al. 2020). It must be considered that this steel had a high COF, but even the AISI 316L have a COF not lower than 0.75 with running-in behavior (Dogan, Findik, and Oztarhan 2003). The wear particles are not only a combination of the steel and the coating, but also the elements of the AISI 52100 from the ball counterpart, which is known to have more iron and less chromium. The AISI 52100 (against AISI 304) has proven to be that predominant source of wear due to its delamination (Zandrahimi et al. 2007).

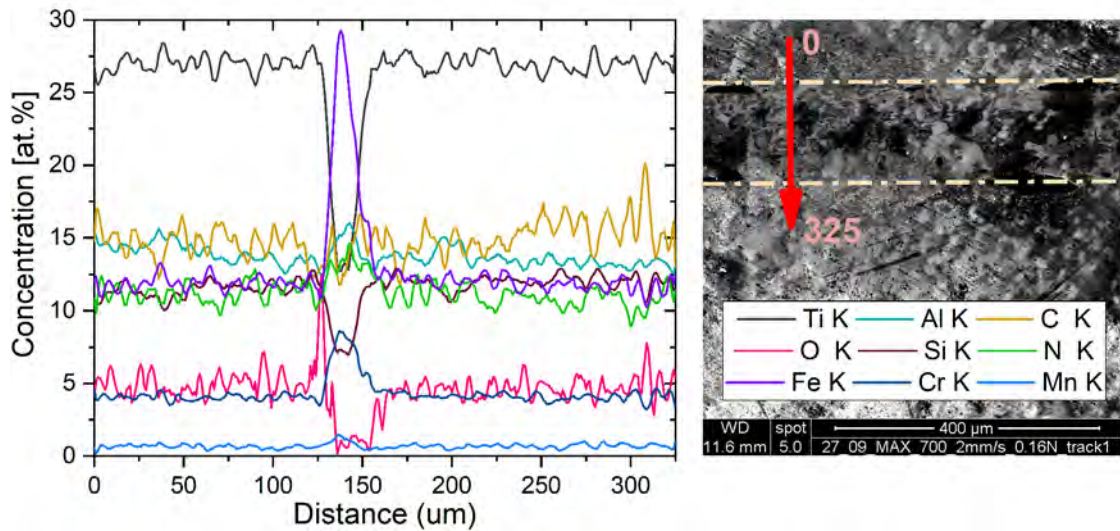
Figure 3.6: Scanning electron microscope-energy dispersive X-Ray detector (SEM-EDX) analysis of Ti_2AlC at 15 kV. SEM micrographs of the wear track at 2 mm s^{-1} and 0.16 N. The orange dashed line shows the position of the wear track.

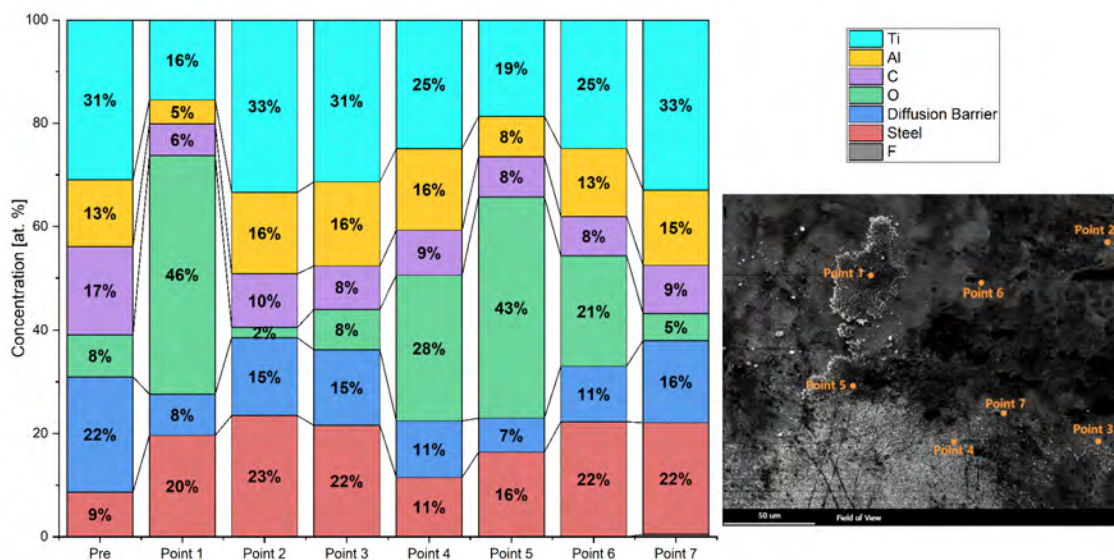
Figure 3.7: EDX points analysis on the scanning electron microscope (SEM) images of Ti_2AlC wear particles around a wear track at 2 mm s^{-1} and 0.16 N .

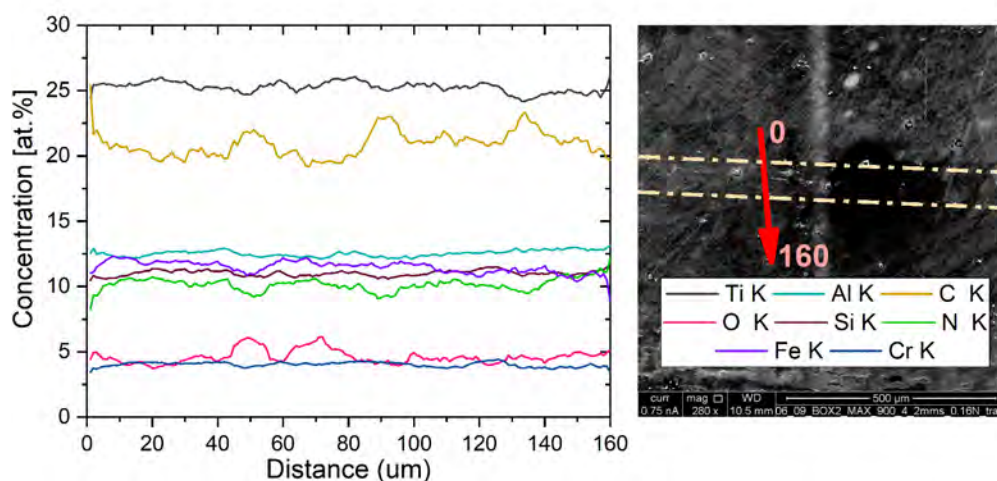
Figure 3.8: Scanning electron microscope-energy dispersive X-Ray detector (SEM-EDX) analysis of Ti_3AlC_2 at 15 kV . SEM micrographs of the wear track at 2 mm s^{-1} and 0.16 N . The orange dashed line shows the position of the wear track.

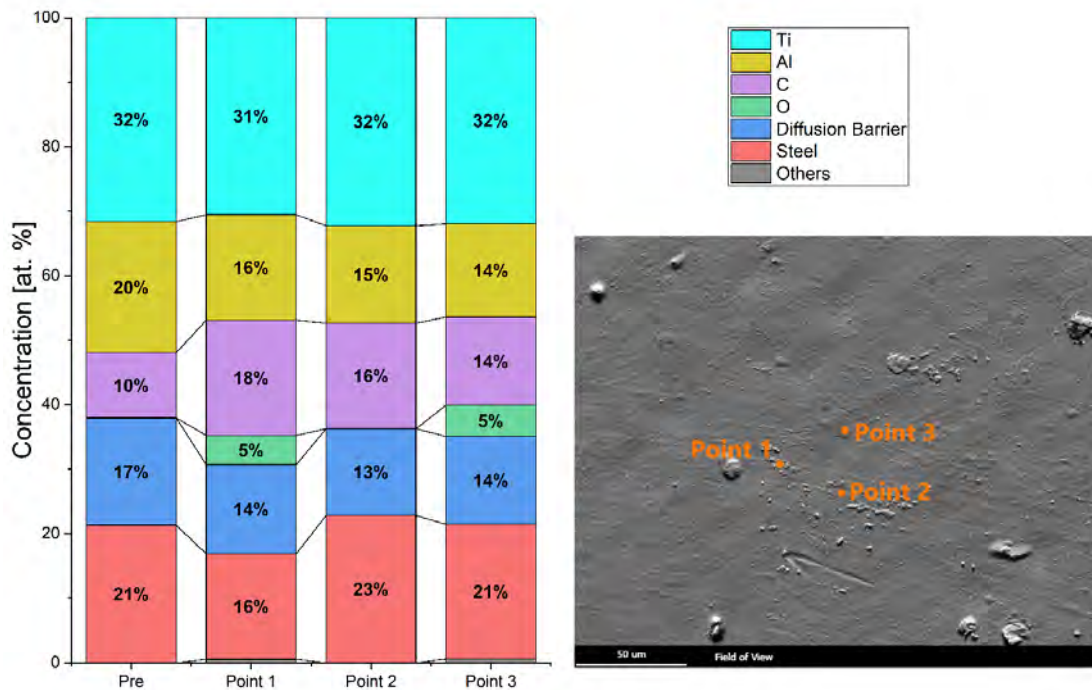
Figure 3.9: EDX points analysis on the scanning electron microscopy (SEM) images of Ti_3AlC_2 wear particles around a wear track at 2 mm s^{-1} and 0.16 N .

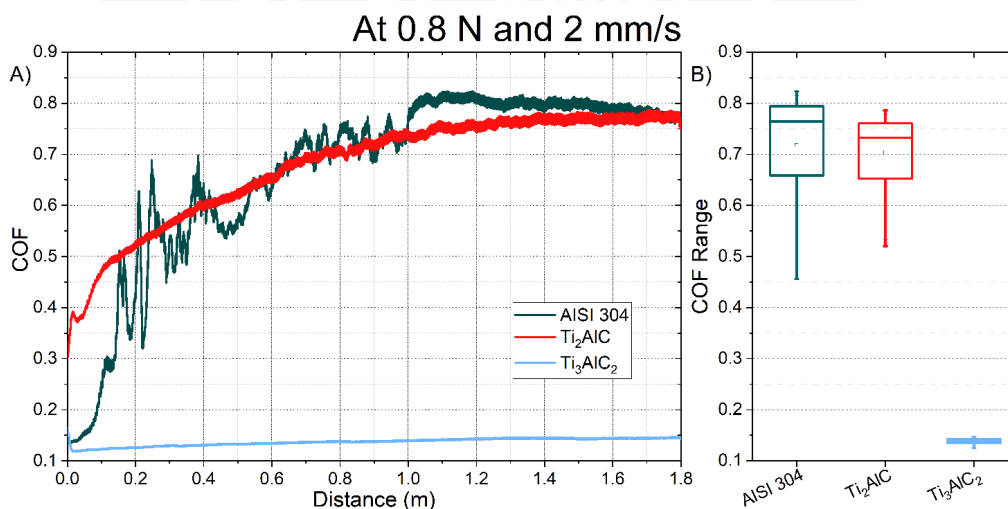
Figure 3.10: COF analysis for Steel, Ti_2AlC and Ti_3AlC_2 at 2 mm s^{-1} and 0.8 N .

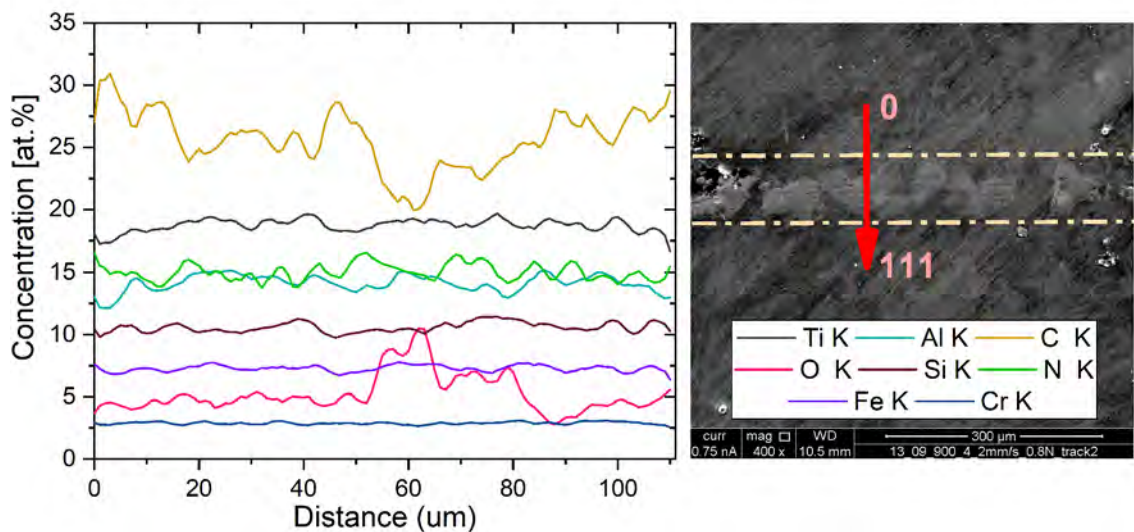
Figure 3.13: Scanning electron microscope-energy dispersive X-Ray detector (SEM-EDX) analysis of Ti_3AlC_2 at 15 kV. SEM micrographs of the wear track at 2 mm s^{-1} and 0.8 N. The orange dashed line shows the position of the wear track.

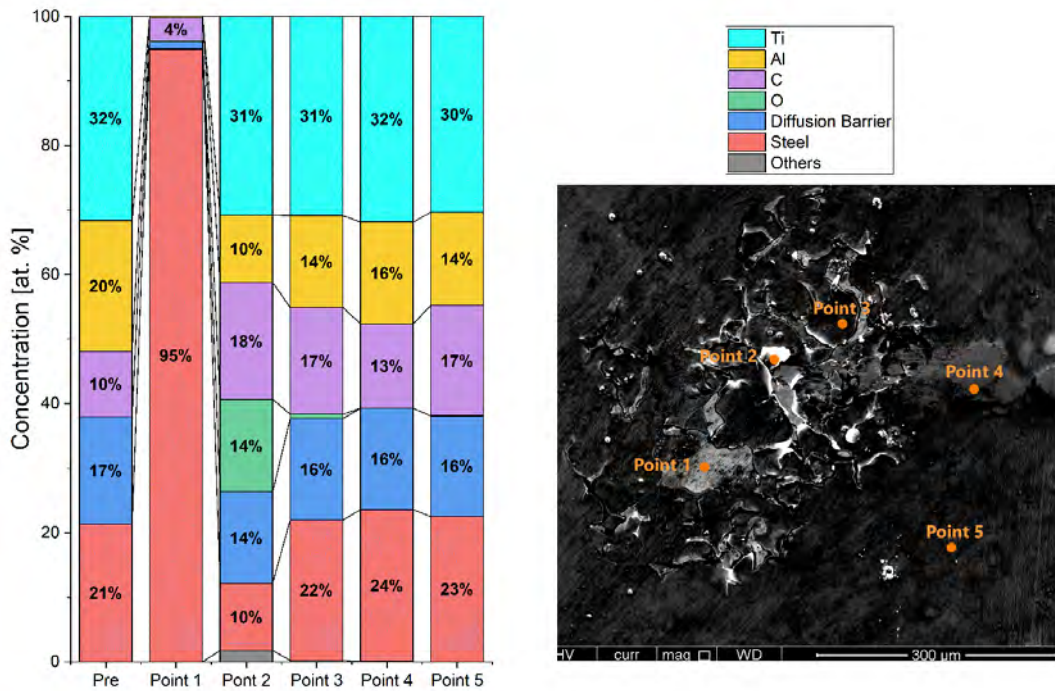
Figure 3.14: EDX points analysis on the scanning electron microscopy (SEM) images of Ti_3AlC_2 wear particles around a wear track at 2 mms^{-1} and 0.8 N .

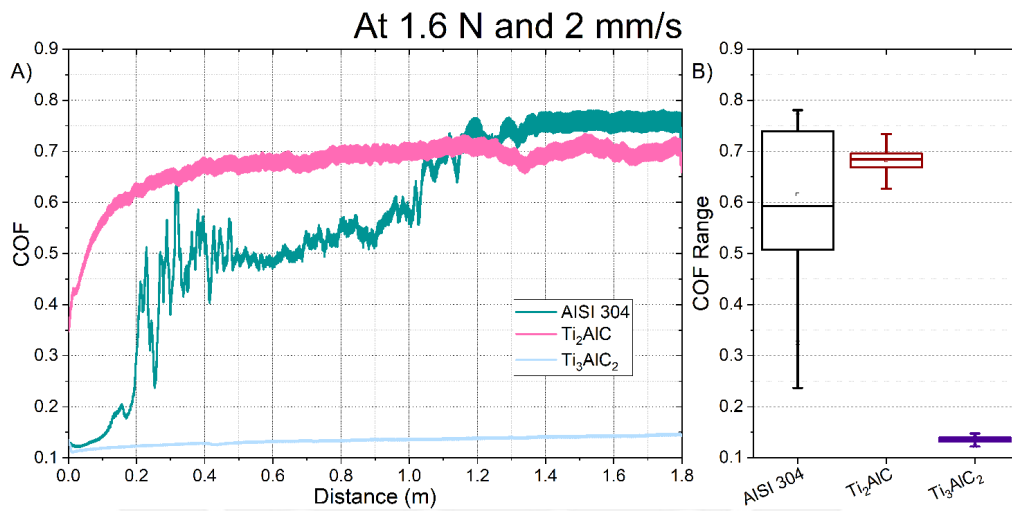
Figure 3.15: COF analysis for Steel, Ti_2AlC and Ti_3AlC_2 at 2 mm s^{-1} and 1.6 N .

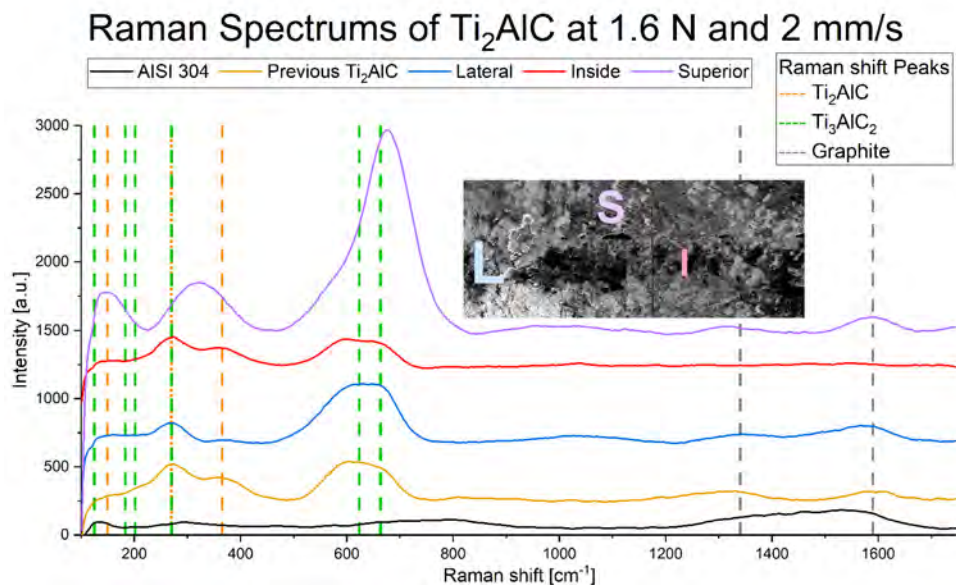
Figure 3.16: Raman spectrums of Ti_2AlC at 700°C MAX at 2 mm s^{-1} and 1.6N , where the wear was maximum.

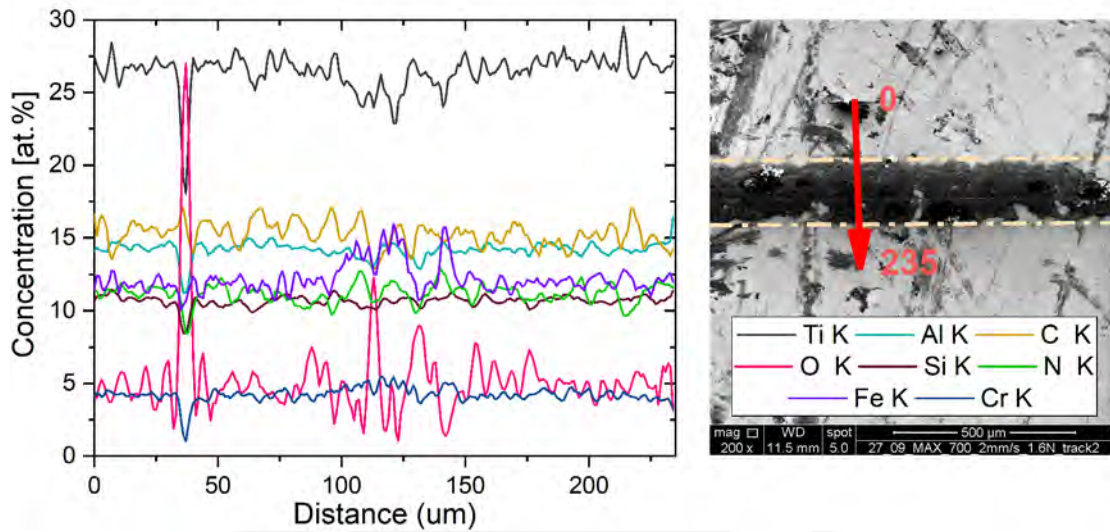
Figure 3.17: Scanning electron microscope-energy dispersive X-Ray detector (SEM-EDX) analysis of Ti_2AlC at 15 kV. SEM micrographs of the wear track at 2 mm s^{-1} and 1.6 N . The orange dashed line shows the position of the wear track.

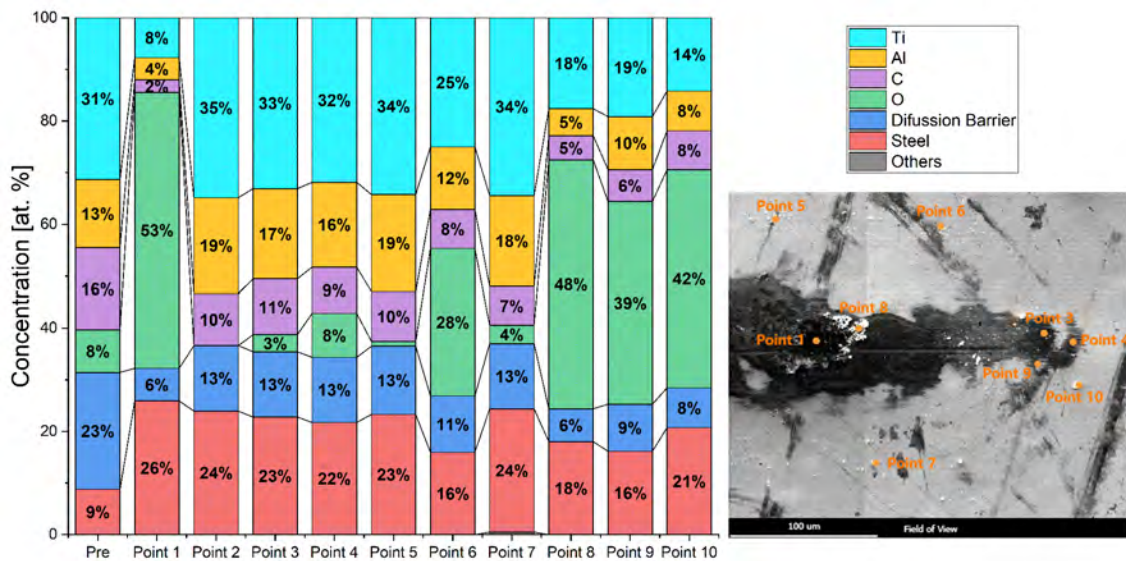
Figure 3.18: EDX points analysis on the scanning electron microscopy (SEM) images of Ti_2AlC wear particles around a wear track at 2 mm s^{-1} and 1.6 N .

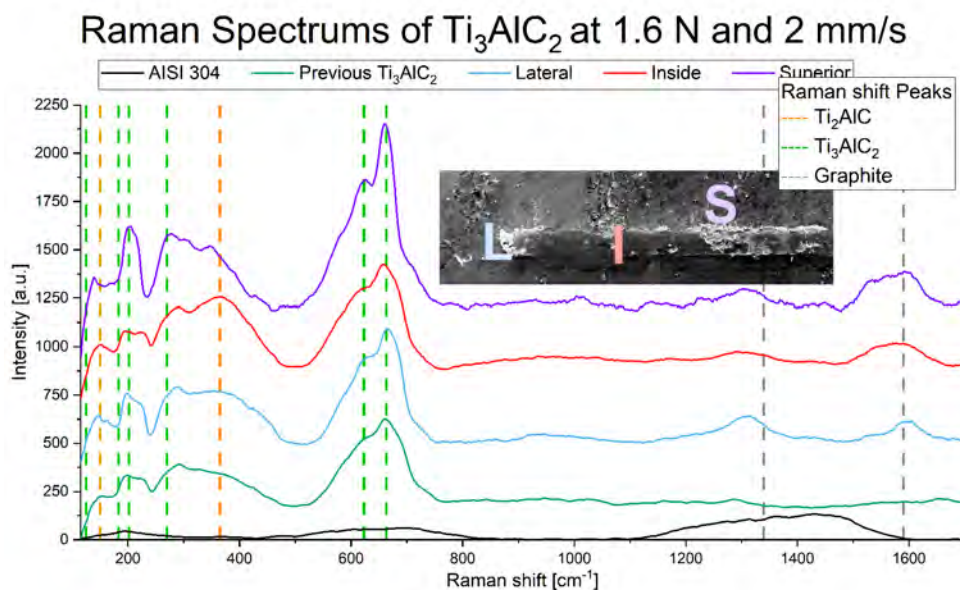
Figure 3.19: Raman spectrums of Ti_3AlC_2 at $950^\circ C$ MAX at 2 mm s^{-1} and 1.6 N , where the wear was maximum

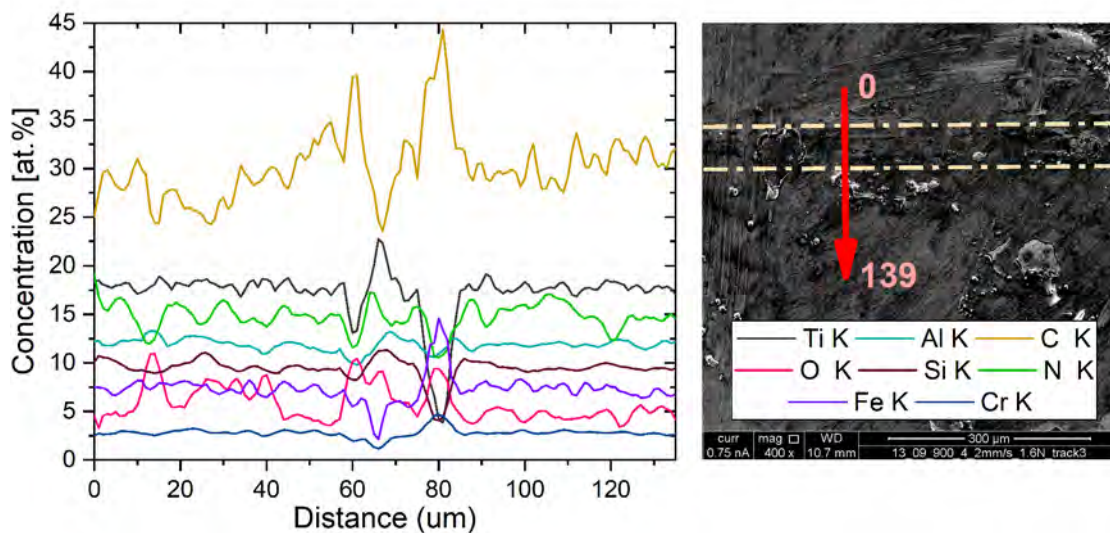
Figure 3.20: Scanning electron microscope-energy dispersive X-Ray detector (SEM-EDX) analysis of Ti_3AlC_2 at 15 kV. SEM micrographs of the wear track at 2 mm s^{-1} and 1.6 N. The orange dashed line shows the position of the wear track.

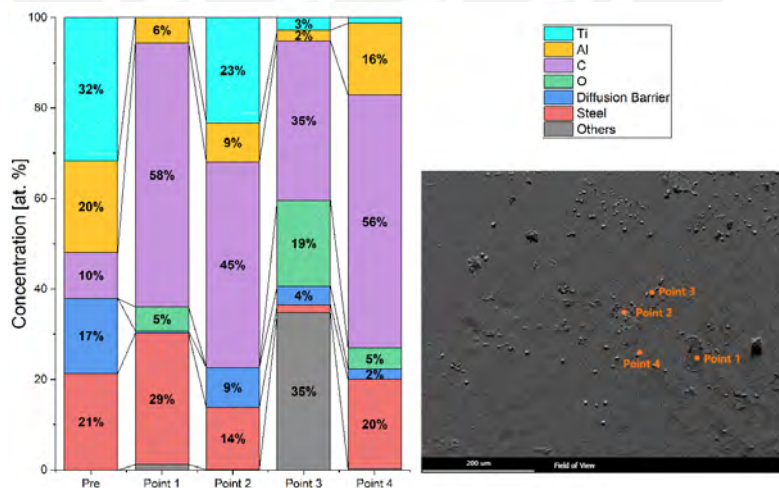
Figure 3.21: EDX points analysis on the scanning electron microscopy (SEM) images of Ti_3AlC_2 wear particles around a wear track at 2 mm s^{-1} and 1.6 N.

Even when point 1 and 4 have high levels of steel, their sources are different since point 4 is a particles from the ball with high oxidation and carbon.

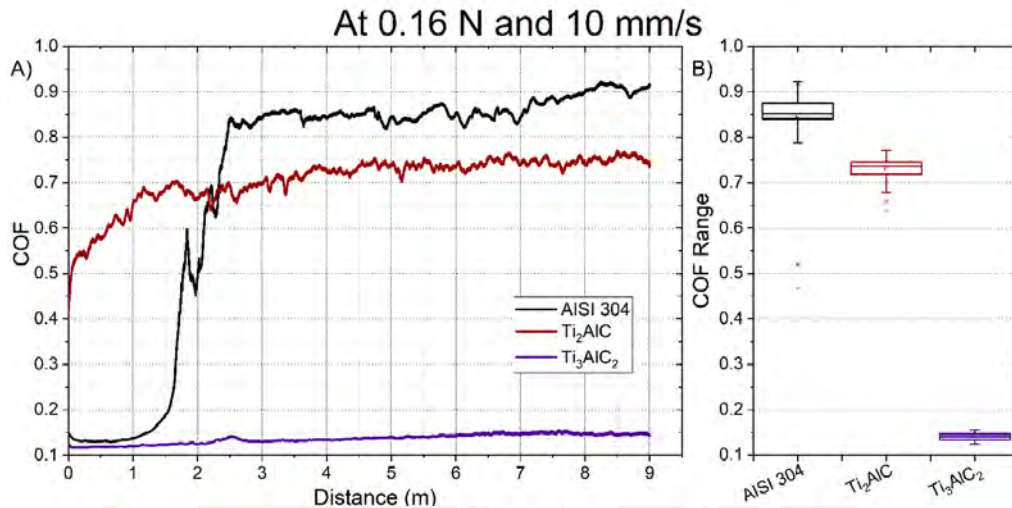
Figure 3.22: COF analysis for Steel, Ti_2AlC and Ti_3AlC_2 at 10 mm s^{-1} and 0.16 N .

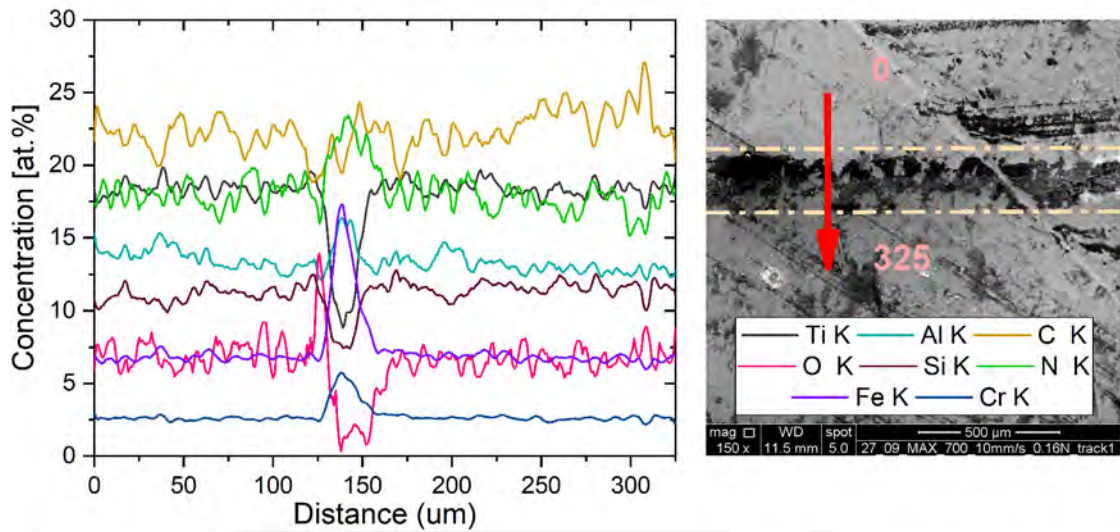
Figure 3.23: Scanning electron microscope-energy dispersive X-Ray detector (SEM-EDX) analysis of Ti_2AlC at 15 kV. SEM micrographs of the wear track at 10 mm s^{-1} and 0.16 N. The orange dashed line shows the position of the wear track.

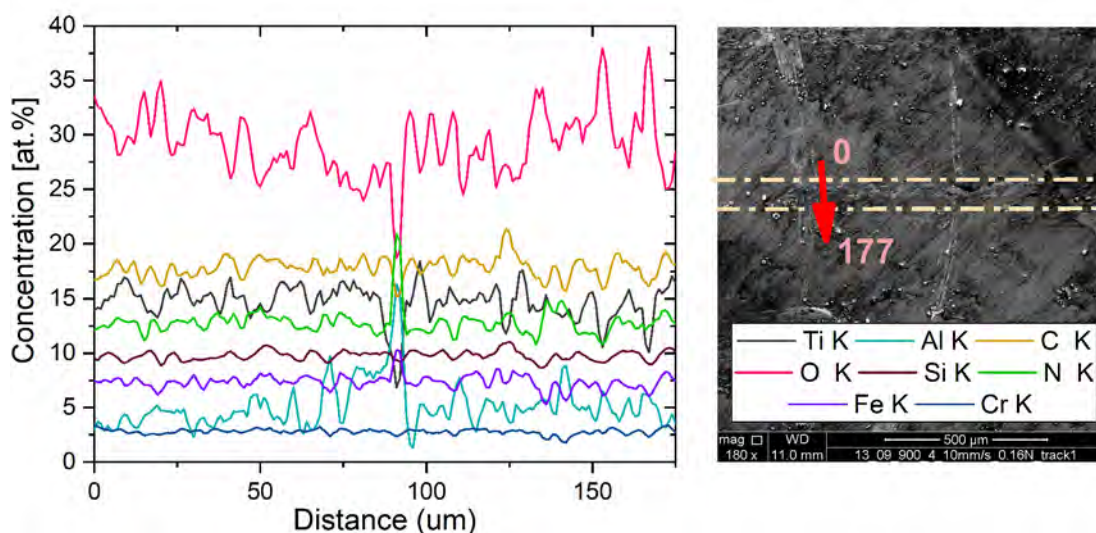
Figure 3.25: Scanning electron microscope-energy dispersive X-Ray detector (SEM-EDX) analysis of Ti_3AlC_2 at 15 kV. SEM micrographs of the wear track at 10 mm s^{-1} and 0.16 N. The orange dashed line shows the position of the wear track.

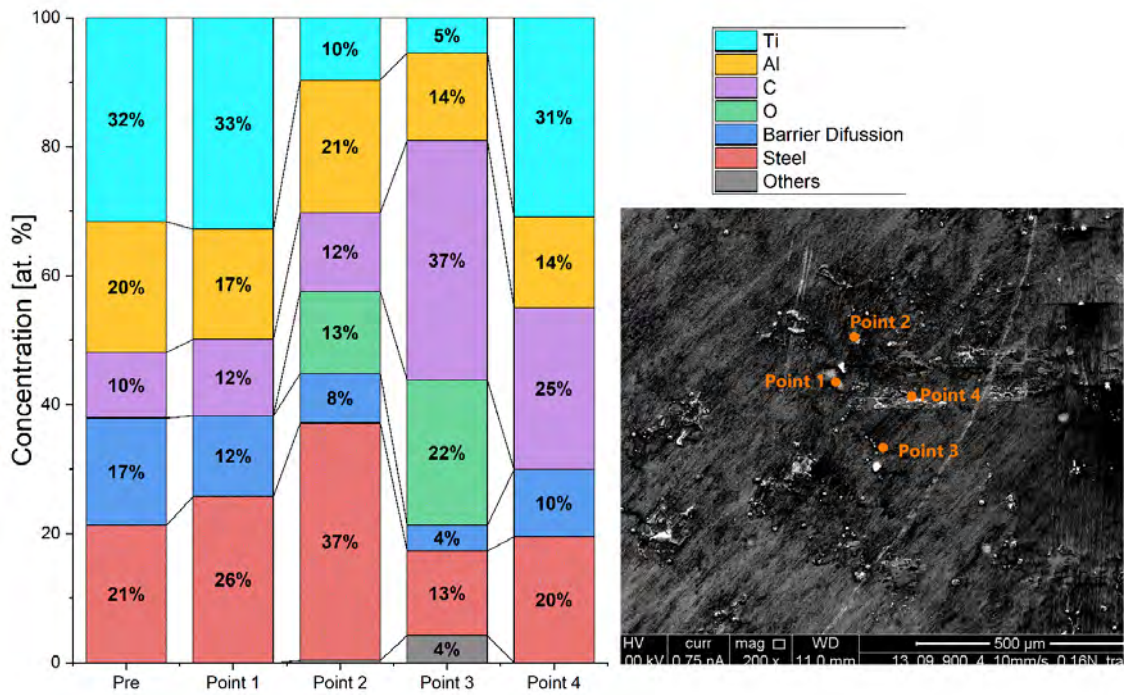
Figure 3.26: EDX points analysis on the scanning electron microscopy (SEM) images of Ti_3AlC_2 wear particles around a wear track at 10 mm s^{-1} and 0.16 N .

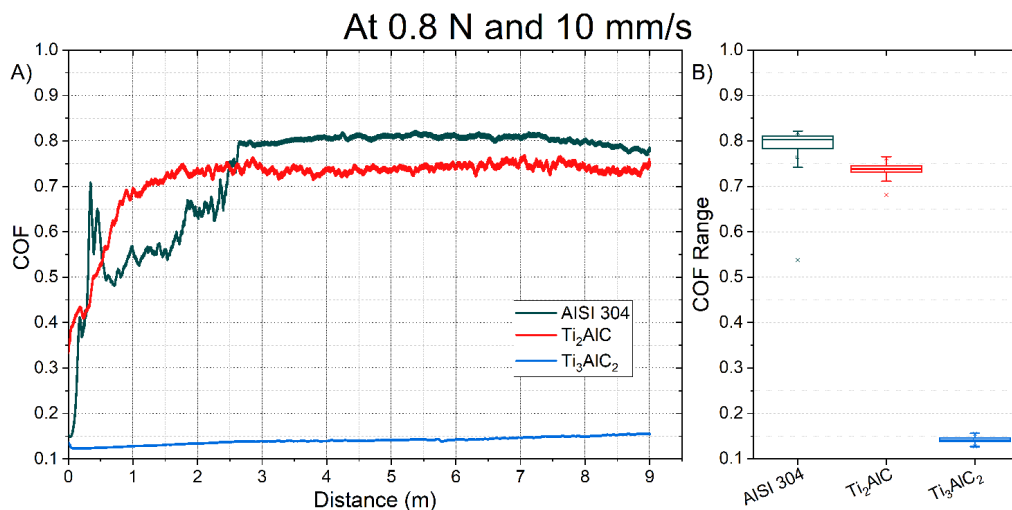
Figure 3.27: COF analysis for Steel, Ti_2AlC and Ti_3AlC_2 at 10 mm s^{-1} and 0.8 N .

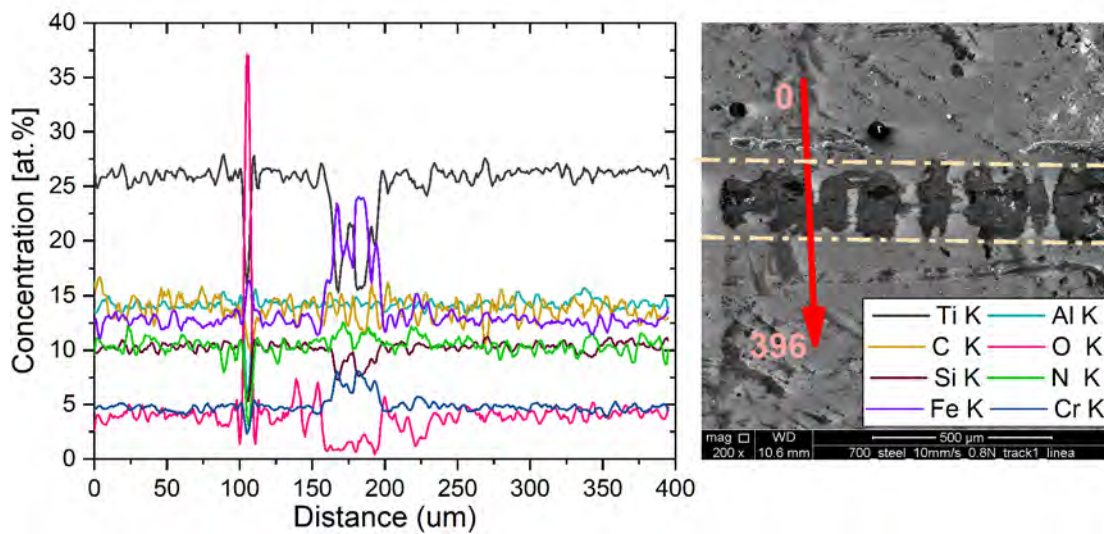
Figure 3.28: Scanning electron microscope-energy dispersive X-Ray detector (SEM-EDX) analysis of Ti_2AlC at 15 kV. SEM micrographs of the wear track at 10 mm s^{-1} and 0.8 N. The orange dashed line shows the position of the wear track.

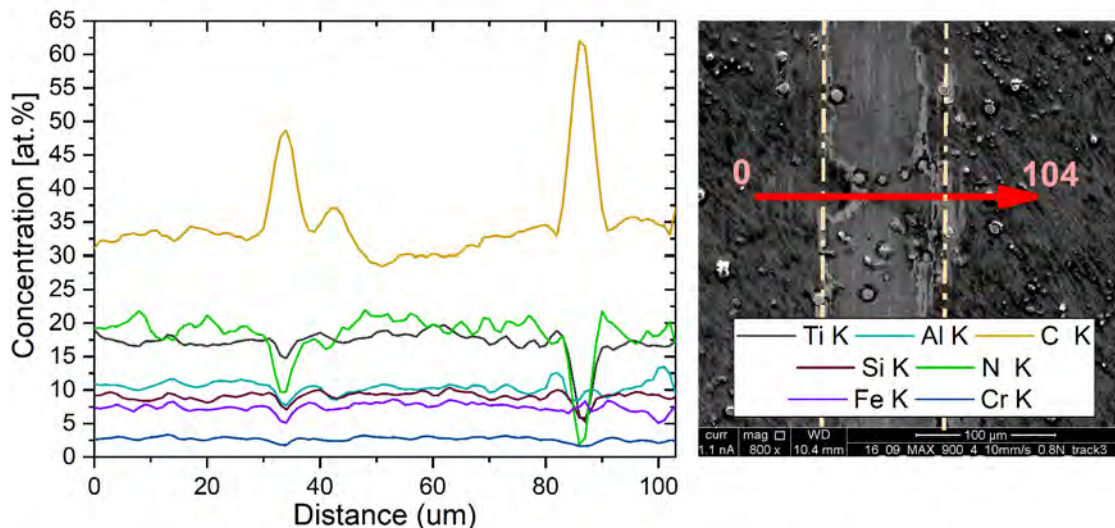
Figure 3.30: Scanning electron microscope-energy dispersive X-Ray detector (SEM-EDX) analysis of Ti_3AlC_2 at 15 kV. SEM micrographs of the wear track at 10 mm s^{-1} and 0.8 N. The orange dashed line shows the position of the wear track.

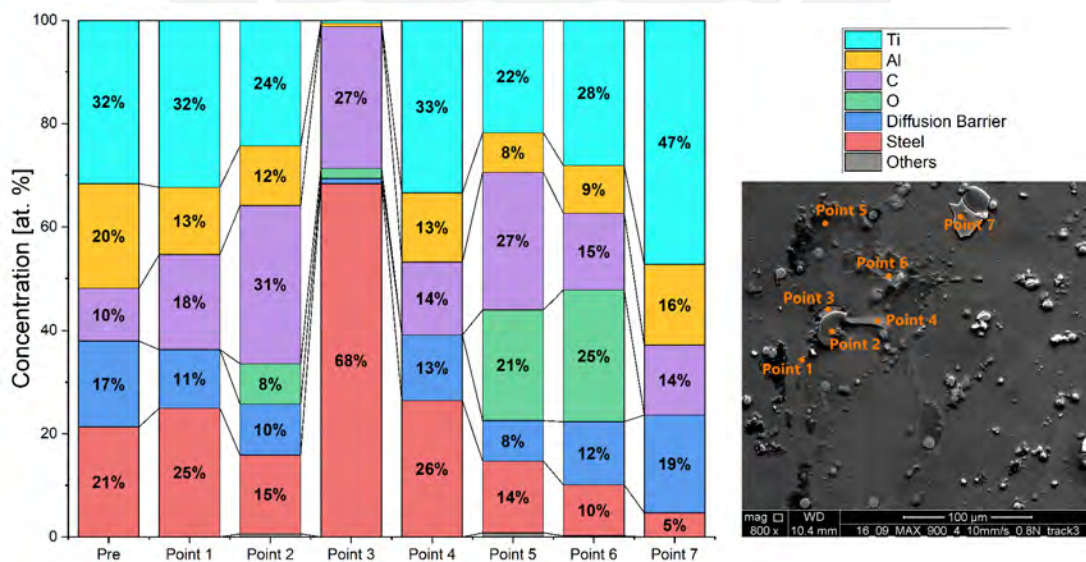
Figure 3.31: EDX points analysis on the scanning electron microscopy (SEM) images of Ti_3AlC_2 wear particles around a wear track at 10 mm s^{-1} and 0.8 N.

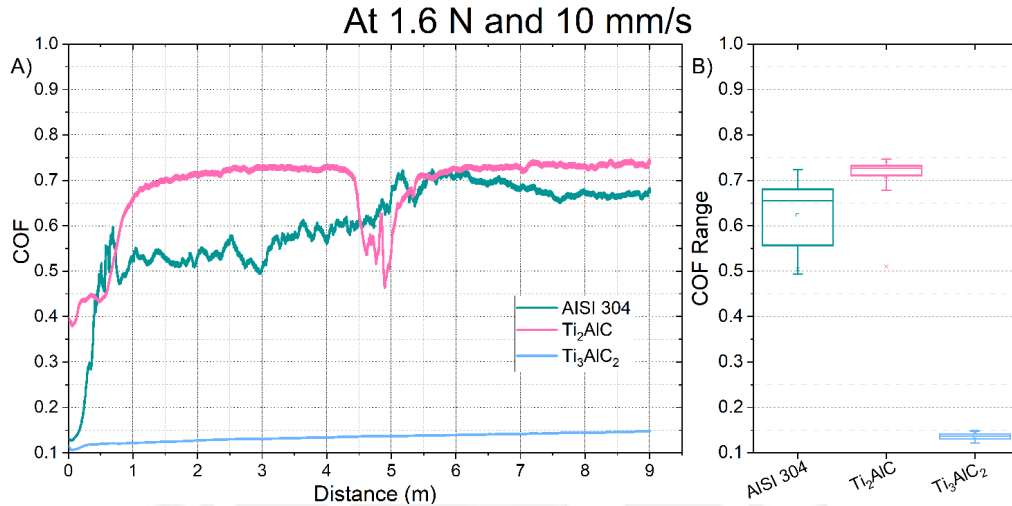
Figure 3.32: COF analysis for Steel, Ti_2AlC and Ti_3AlC_2 at 10 mm s^{-1} and 1.6 N .

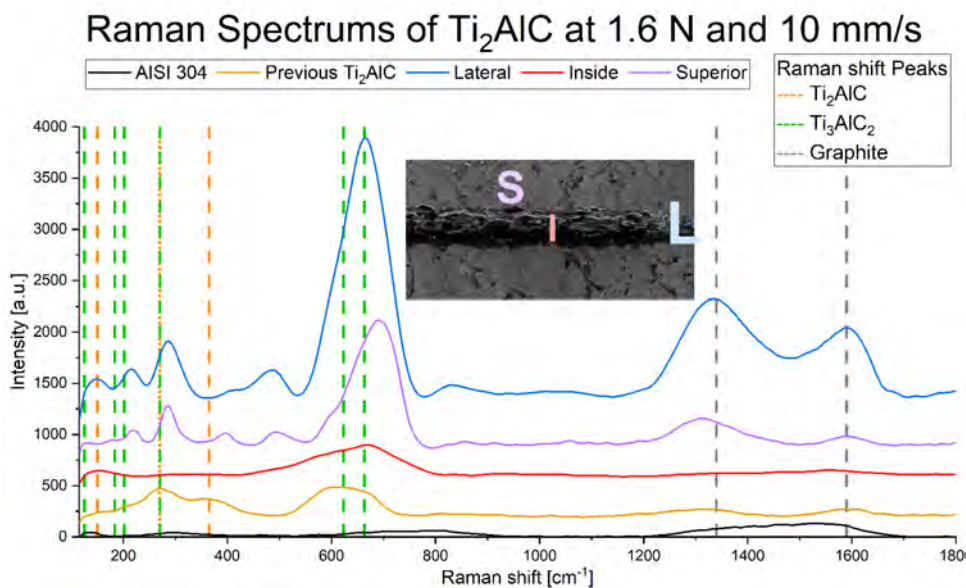
Figure 3.33: Raman spectrums of Ti_2AlC at $700^{\circ}C$ MAX at 10 mm s^{-1} and $1.6N$, where the wear was maximum
