**Morphological and tribological evaluation of the use of Ti_2AlC
and Ti_3AlC_2 MAX Phases as a surgical AISI 304 stainless steel
coating for a future hip replacement femoral head coating**

Tesis para obtener el título profesional de Ingeniera Biomédica

Gianella Alexandra Ccama Castro

Lima, Diciembre, 2023

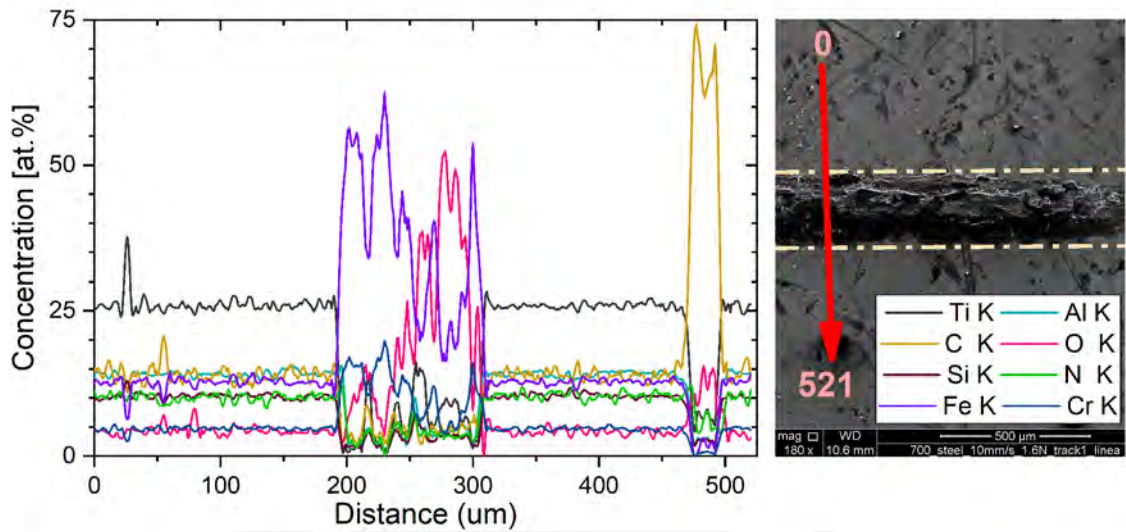
Figure 3.34: Scanning electron microscope-energy dispersive X-Ray detector (SEM-EDX) analysis of Ti_2AlC at 15 kV. SEM micrographs of the wear track at 10 mm s^{-1} and 1.6 N. The orange dashed line shows the position of the wear track.

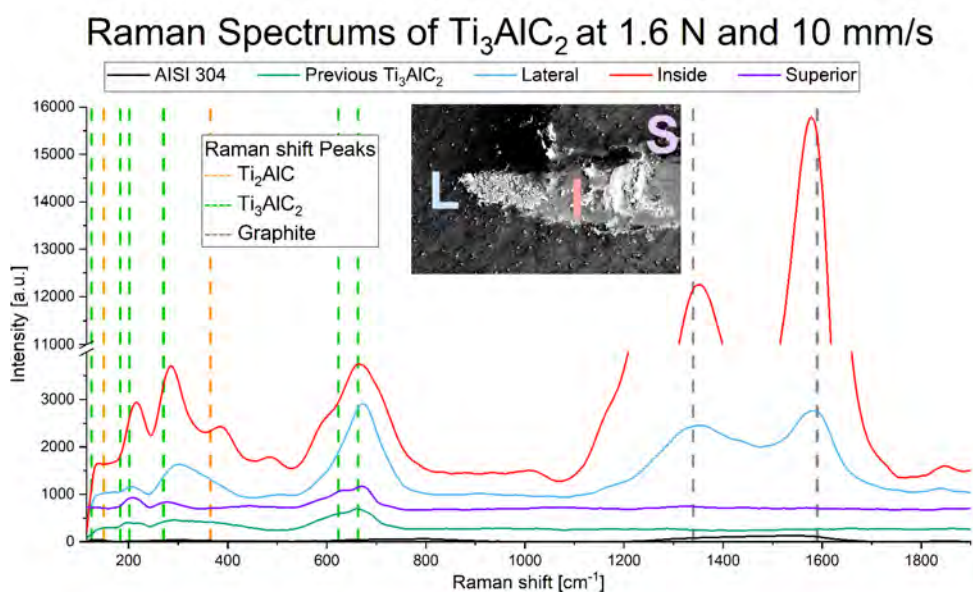
Figure 3.36: Raman spectrums of Ti_3AlC_2 at $950^\circ C$ MAX at 10 mm s^{-1} and $1.6N$, where the wear was maximum

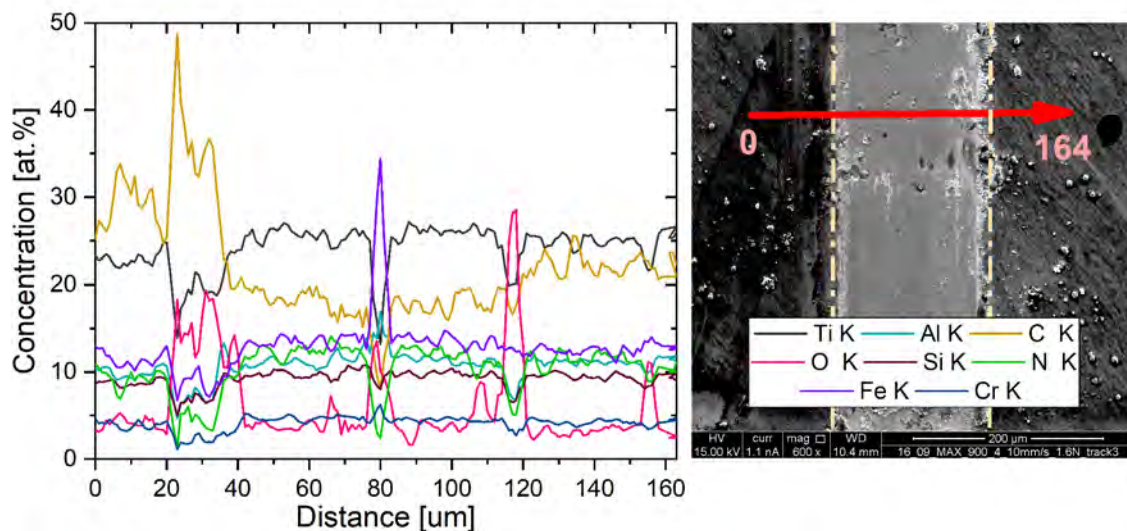
Figure 3.37: Scanning electron microscope-energy dispersive X-Ray detector (SEM-EDX) analysis of Ti_3AlC_2 at 15 kV. SEM micrographs of the wear track at 10 mms^{-1} and 1.6 N. The orange dashed line shows the position of the wear track.

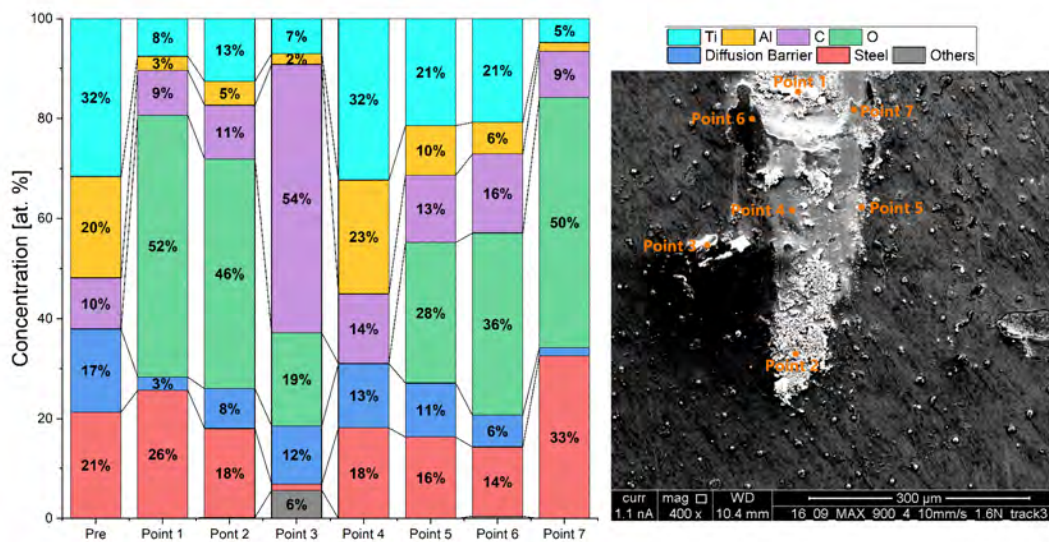
Figure 3.38: EDX points analysis on the scanning electron microscopy (SEM) images of Ti_3AlC_2 wear particles around a wear track at 10 mm s^{-1} and 1.6 N.

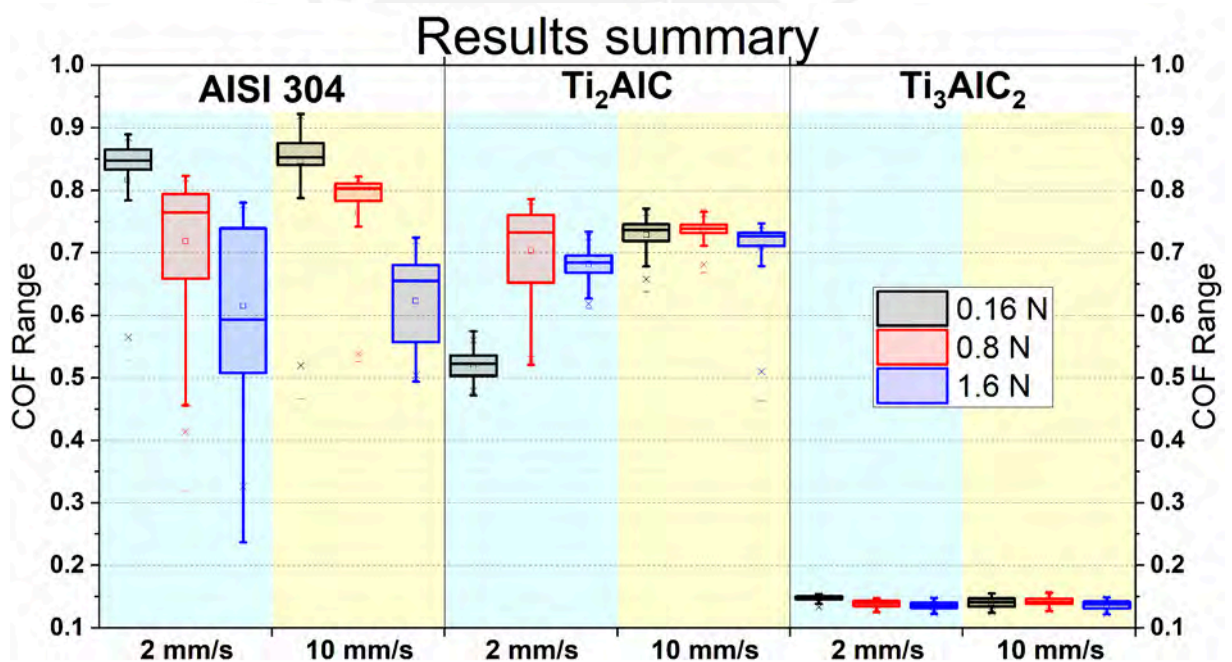
Figure 3.39: Comparison of COFs analysis for Steel, Ti_2AlC and Ti_3AlC_2 at each speed and force combination.
